## Re: CRC Drilled Shaft Test Program BS-1 Shaft Casing Damage

This letter presents our analysis of the casing damage that occurred while installing the BS-1 shaft for the Columbia River Crossing Shaft Test program on May 21, 2012 and responds to related comments by WSDOT.

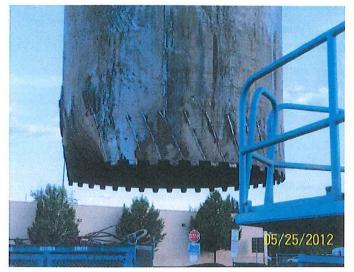
Several photographs are provided below which show the extent of damage at the

bottom of the permanent casing that was caused when oscillating at a depth of approximately 215-ft in Shaft BS-1.

In our opinion, this damage was caused when the oscillator rotated the casing backwards and forwards in the presence of the round boulders shown in the photographs on the previous page.

In one instance, the teeth appear to have penetrated a plane of weakness and created a fracture in one boulder. However, it is evident the other boulders rotated when

encountered by the casing teeth and became "wedged" beneath the casing and the outside very dense gravel wall causing the bending of the casing and teeth that is shown in the photographs.

The approximate 5-ft length of casing that was damaged corresponds to the distance

travelled backwards and forwards during an "oscillation" where the casing is rotated by about 25°.
